A Case Study – Forensic Analysis to Characterize an Unknown Source of Methane in Soil Vapour

Site Layout

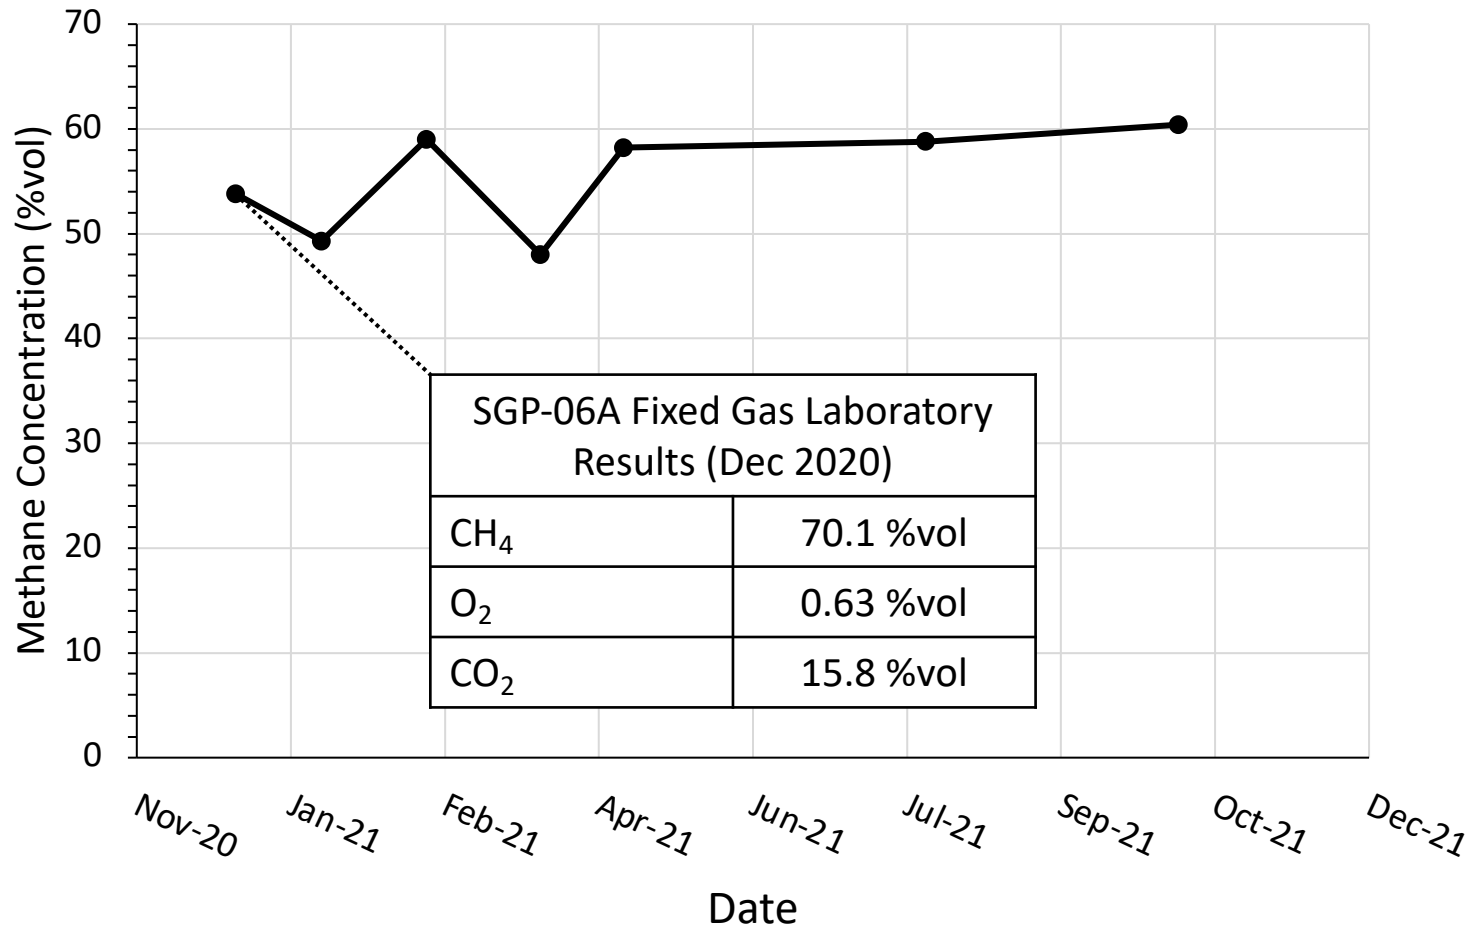
SGP-06A 2020-2021 Field Screening Results

- Laboratory sample collected for fixed gases support December 2020 screening results
- Continuous monitoring of SGP-06A in 2021 and pump test indicate a persistent source
- Methane not historically detected at SGP-06A (2005, 2013, and 2014)

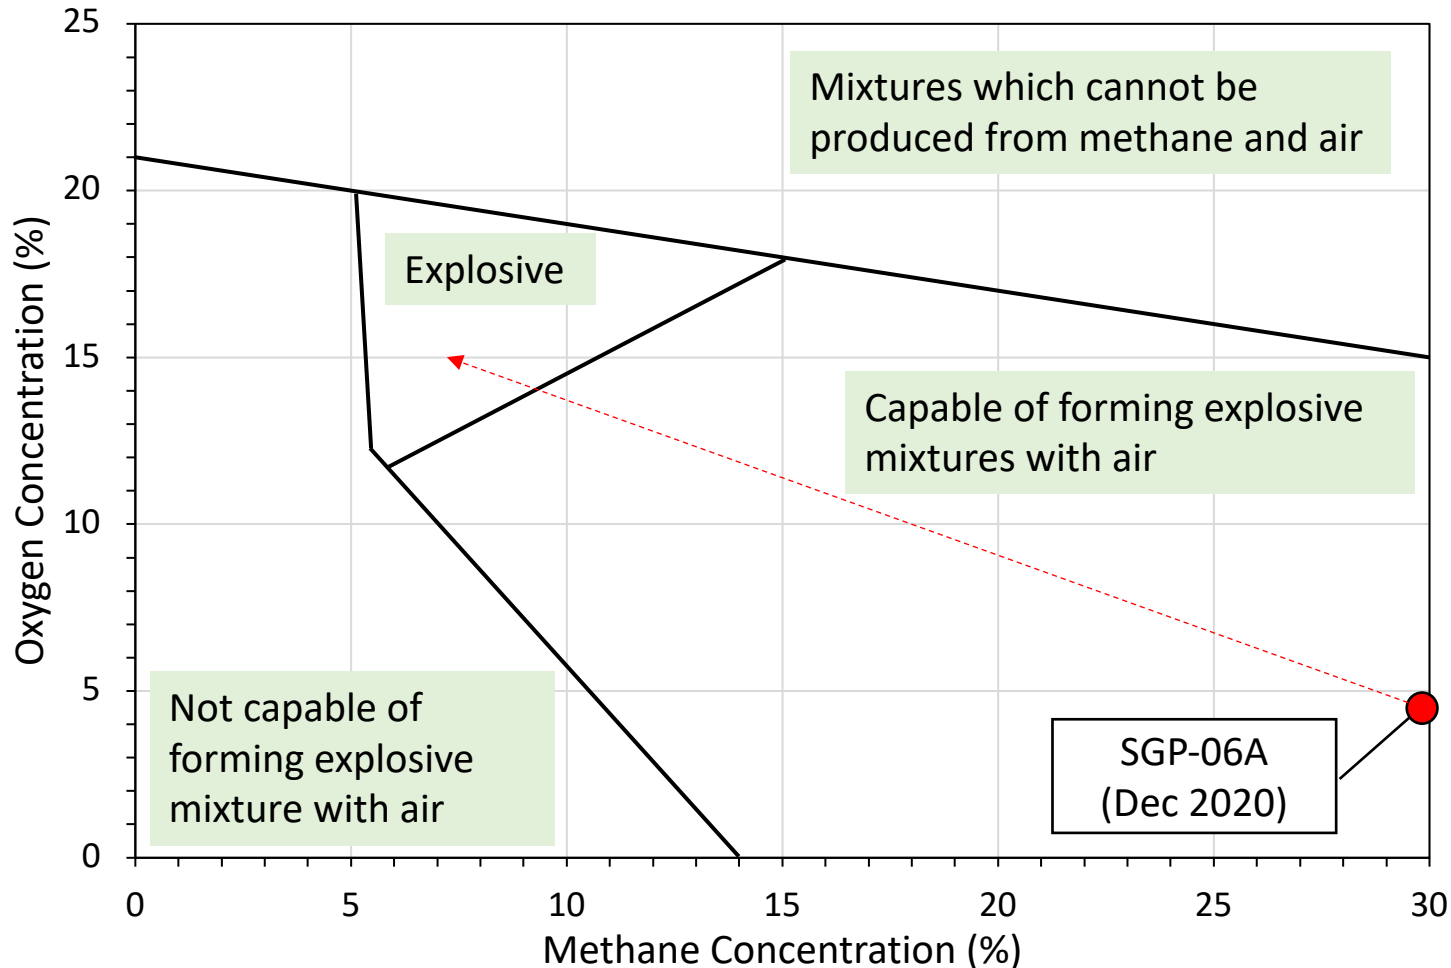
Explosive Mixtures of Methane and Oxygen

- Acute hazard (fire/explosion)
- Off-site residential property owner notified
- At atmospheric conditions
 - lower explosive limit 5 %vol and
 - upper explosive limit 15 %vol
- Dilution presents the potential to form an explosive mixture
- SGP-06A identified to be under constant positive pressure

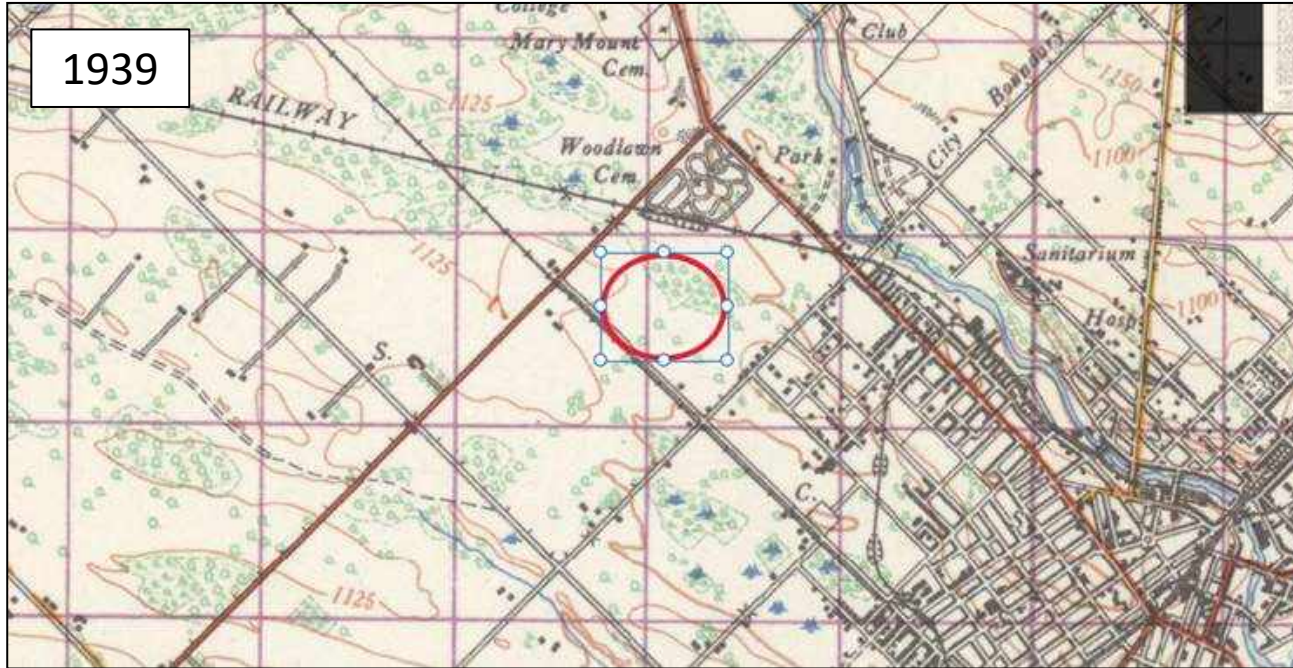
Historical Property Use

Historical property use search revealed no prior use/development before the site began operations in 1965

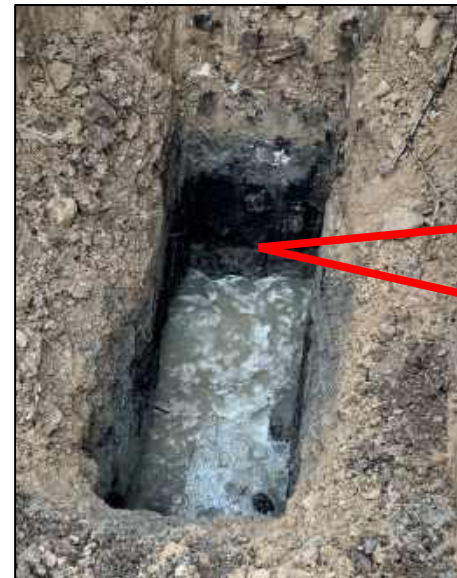
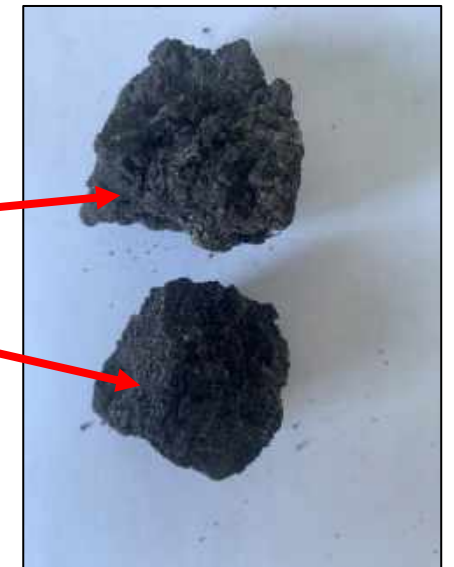
- Soil profile of test pits:
 - 0-0.2 m bgs – topsoil
 - 0.2-1.1 m bgs - brown clay till
 - 1.1 - 1.3 m bgs – gray clay
 - **1.3-1.6 m bgs – black organic-rich layer**
 - 1.6 - 2 m bgs – gray clay
- Water table - ~2 m bgs

- The likely source of methane along the eastern property boundary was of an unusual small organic-rich layer of soil bound between two layers of low-permeability clay layers
- High methane detections were limited to a low-lying saturated area in proximity to SGP-06A
- Test pits demonstrated some venting and aerobic oxidation of methane
- Risk and liability to client mitigated with the source of methane identified – off-site residential property owner notified
