Risk Management Solutions

VIJAY KALLUR, M.Sc., P.Eng., FEC, CSAP
Client Program Manager

The 12th Annual SABCS Conference on
Contaminated Sites
September 22, 2022

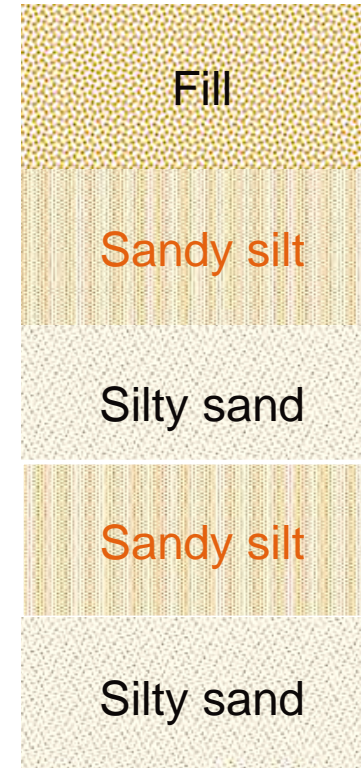
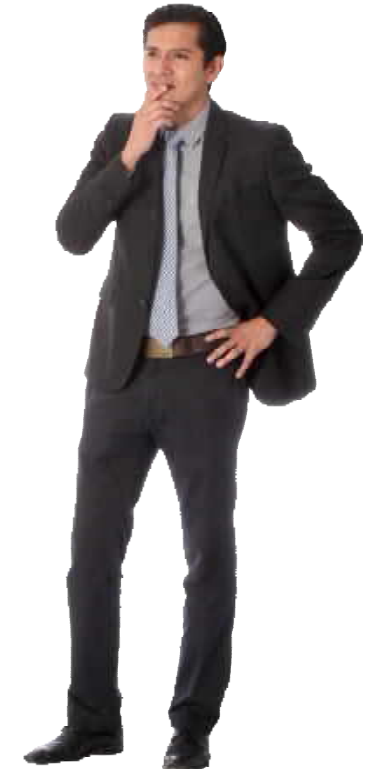
- **Inconsistent Data and Logging – Silty Sand or Sandy silt ?**
- **Stratigraphy onsite – Fill, Bedrock (siltstone or sandstone), Till with gravel/sand lenses?**
- **Depth of Groundwater or multiple aquifers**
- **Plume Size (Vertical and Areal) – LNAPL, DNAPL, GW and Soil Vapour**
- **Preferential Pathways – Utility Corridors, Buried Stream Beds, Fractures in Bedrock**

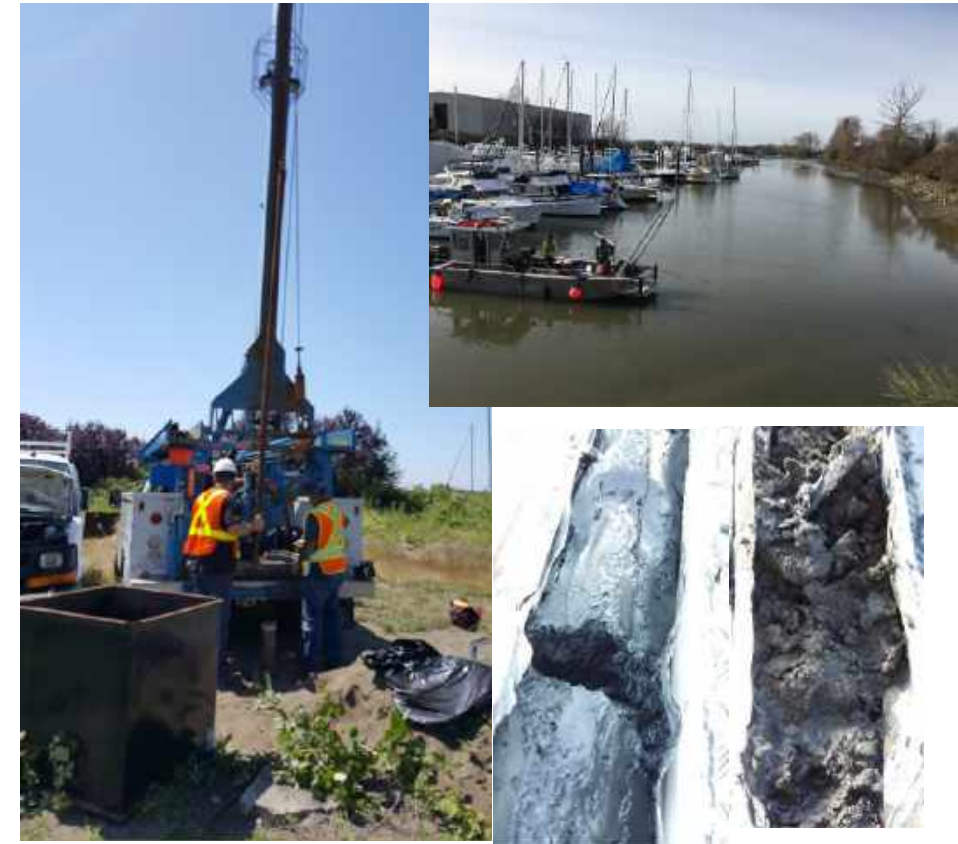
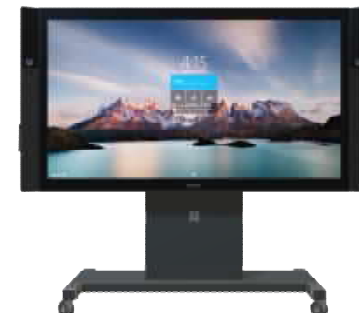
- Drilling logs, **Grain Size Analyses**
- Bail tests, Pump tests
- Data logging of tidal influence
- Analytical data
- Models

- Data and information gap analyses completed, K tests
- Utilized onsite drilling opportunities for low cost data collection – **Grain Size Analyses Profile**
- Decision to obtain a **Shelby tube sample** during field call
- Carried out test to develop soil moisture characteristic curve (Residual W/C = 30% to 40%)

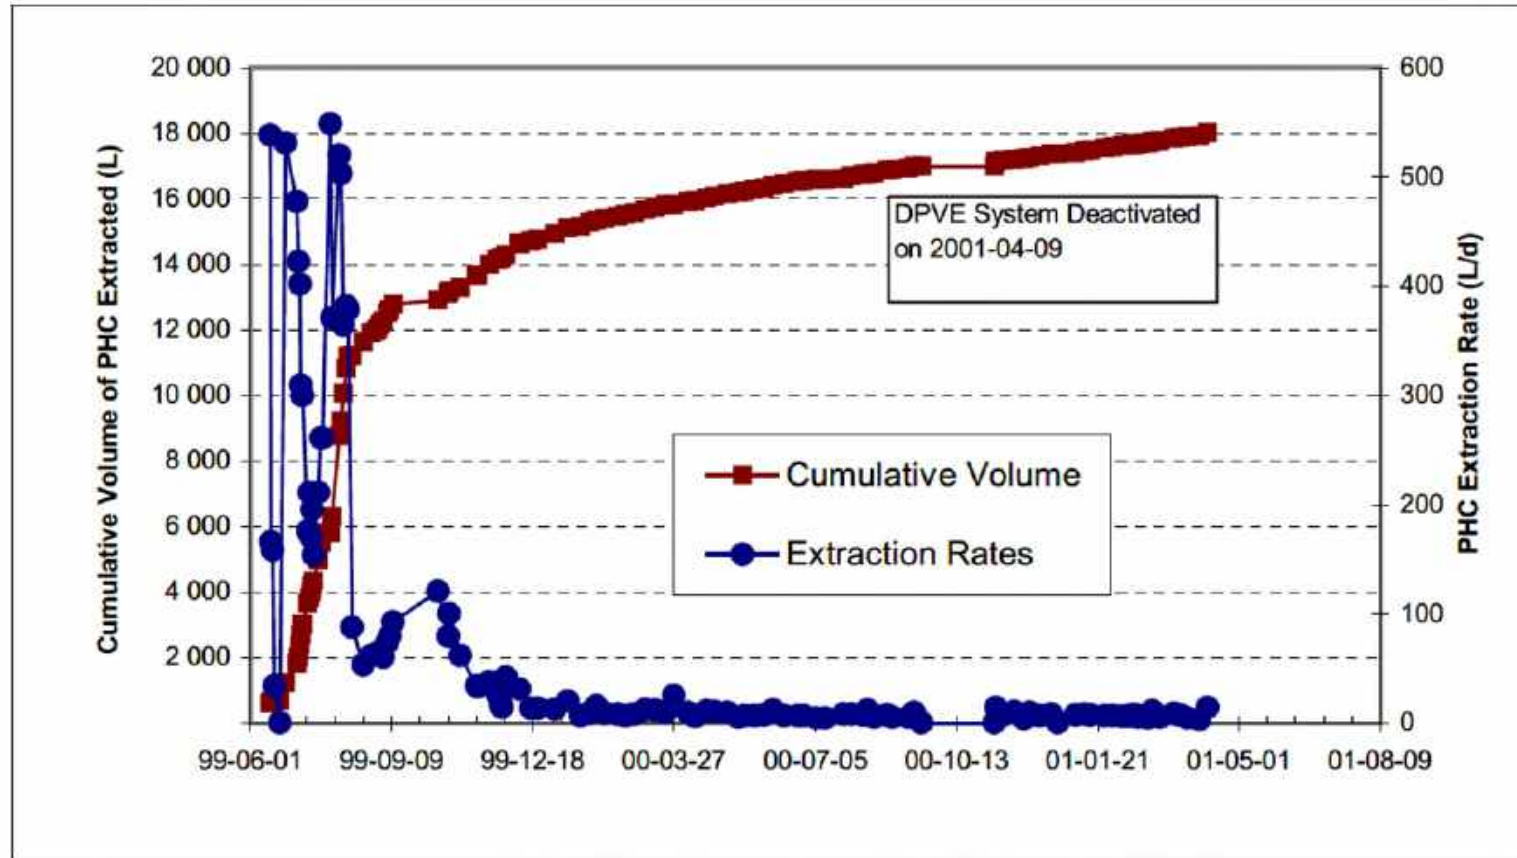
Figure 3. Petroleum Hydrocarbon Extraction History

Table 4. DPVE System Performance Data

Description	Result
Volume of LNAPL Recovered (L): Vapour / Liquid / Dissolved Phase	18 000 / 1 / 35
Volume of Water Extracted (m ³)	1117
Vacuum in Drop-Tubes ("Hg)	11 to 14
Vacuum at Wellheads ("Hg)	5 to 14
Initial Rate of LNAPL Recovery (L/d)	538
Final Rate of LNAPL Recovery (L/d)	<10
Residual VPH in Soil prior to deactivation (mg/kg)	205 to 8 878
VHw in Groundwater (mg/L)	66

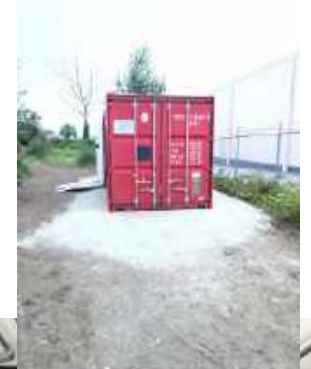
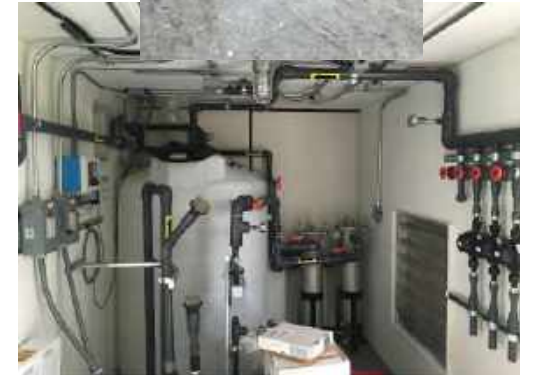
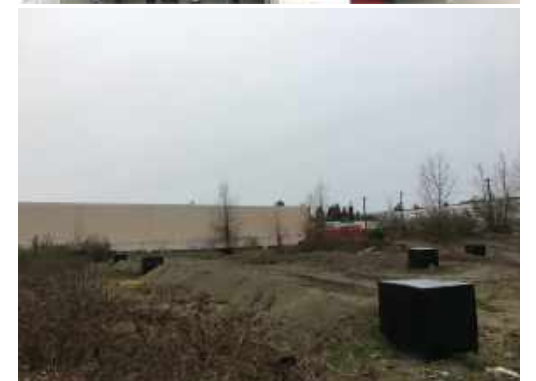
- **Vertical Aquifer Profiling – Physical and Chemical**
- Data collection using loggers for tidal influence
- Modelling
- **Innovative** remedial approach to **enhance bioremediation** for source reduction

Vertical Aquifer Profiling
