Filling in the Data Gaps at Complex Sites before Focused Remediation: Three Case Studies

John Sankey, P.Eng. True Blue Technologies

Western Groundwater Congress 2022 ⁰

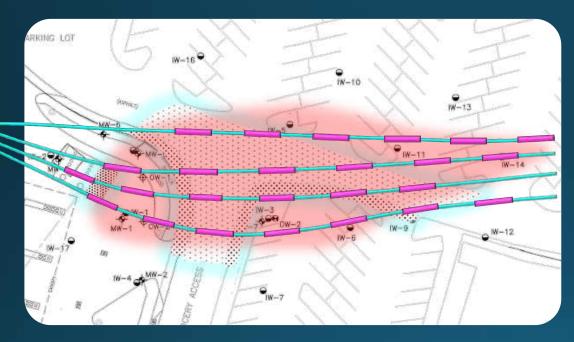
#2a--Gasoline Fuel Release Sites, Plumes Underlying Roads

- Impacts under tanks, adjacent roadway and parking lot
- Resistant adjacent property owners
- 25 Vertebrae Wells installed for treatment
- Shading indicates relative intensity of dosage

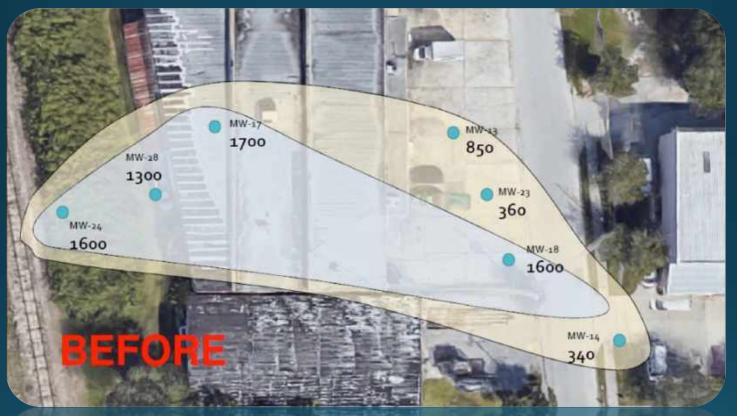
#2b--Solvent Case Study – Minimal Data

Results - 1,2 DCE in ppb

Limited access to buildings-skinny hallways

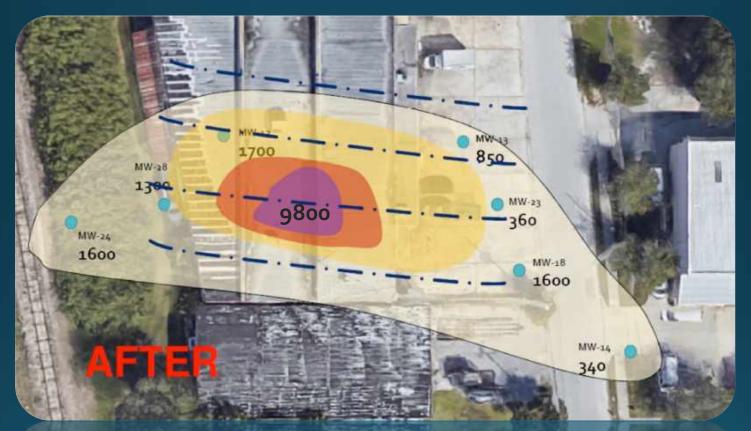
#2b--Solvent Case Study - Data Gaps Filled

- Sampling nested wells identified 4 times More Mass.
- Opposing wells for recirculation--ISCO

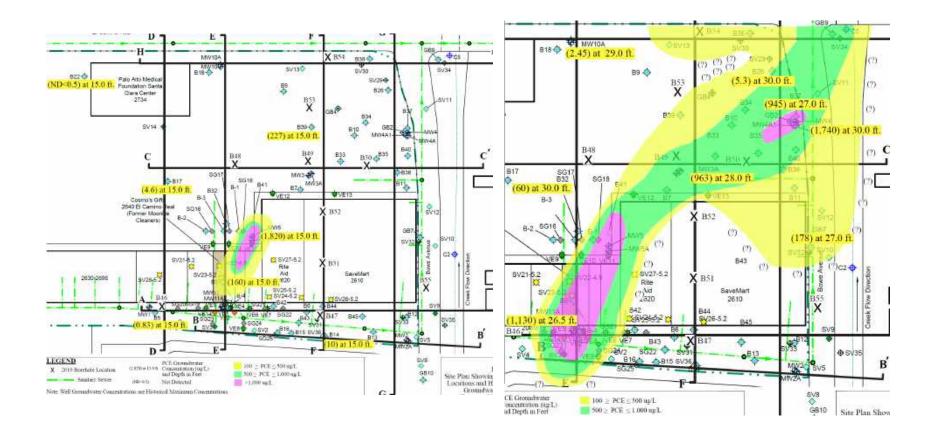
Plume Maps at Different Depth Slices

10 to 15 ft

15 to 20 ft

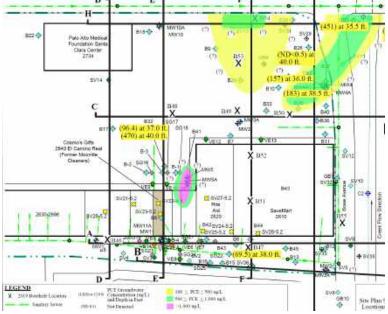
Plume Maps at Different Depth Slices

25 to 30 ft

35 to 40 ft
