Vertex Environmental Inc.

Case Study:
**Significant Return on Investment Achieved by Successfully
Remediating a Challenging Chlorinated Solvent Site**

September 28, 2023

SABCS Workshop

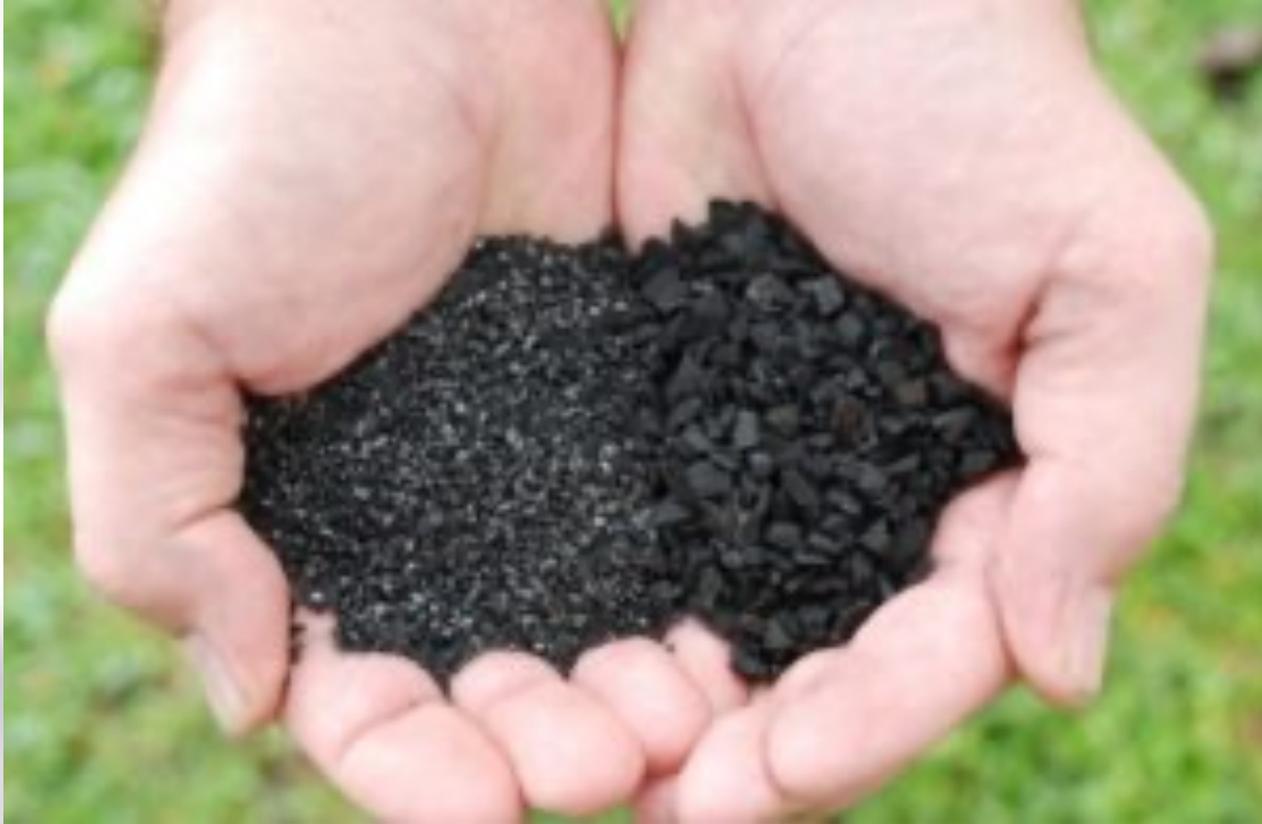
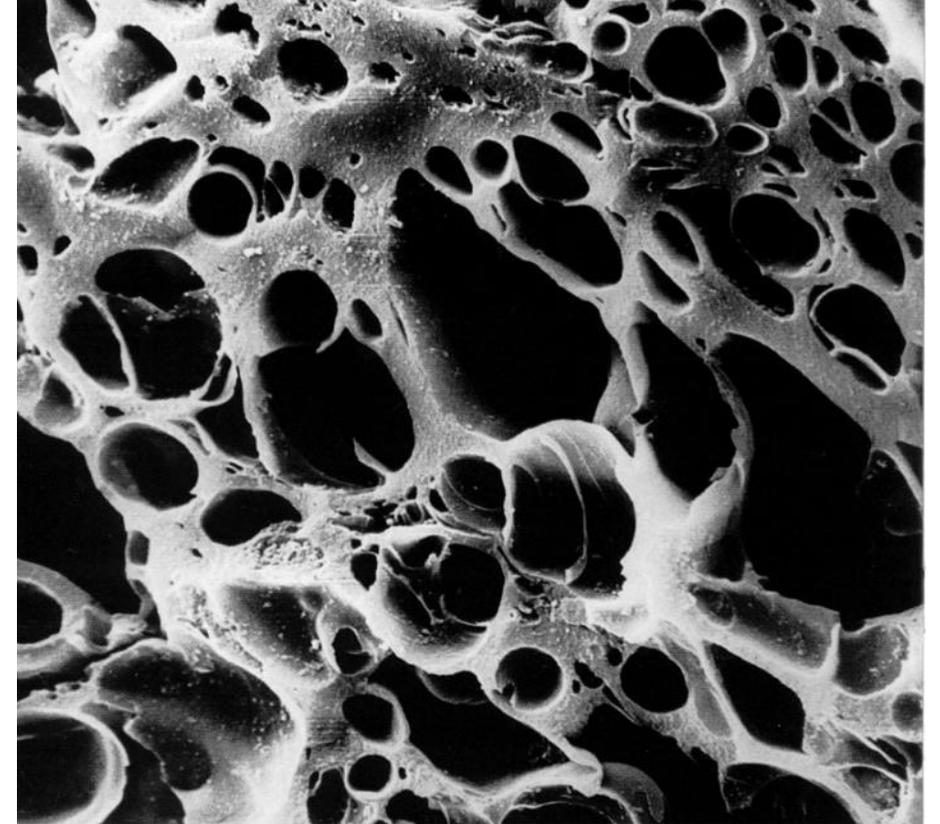
In-Situ Remediation Amendment: Activated Carbon-Based

AC is produced from carbonaceous source materials
(coconut husk, wood, coal, etc.)

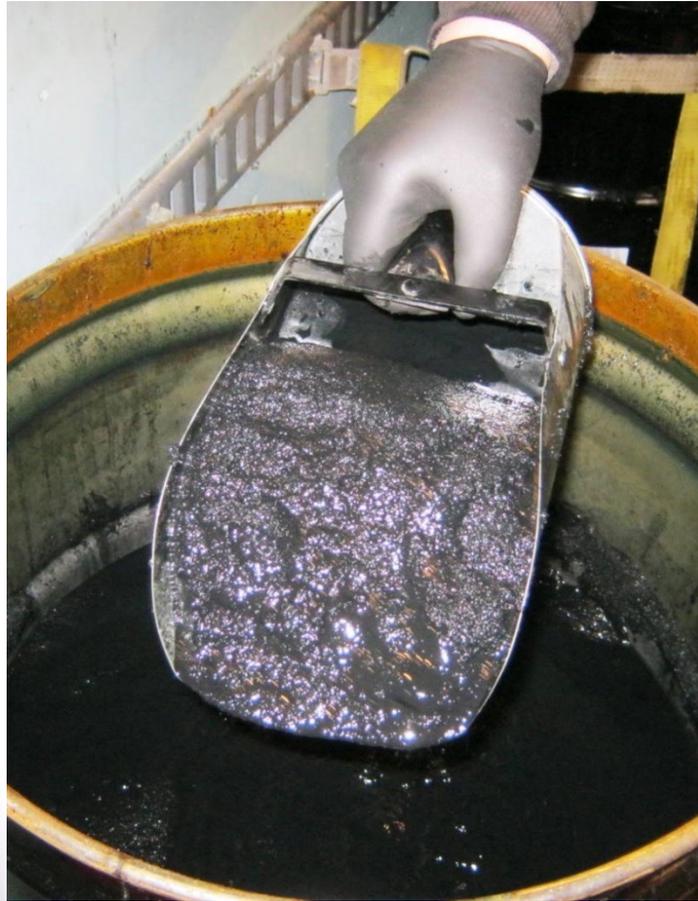
In-Situ Remediation Amendment: Trap & Treat® Technology

BOS 100® - for cVOCs

Activated Carbon & Zero Valent Iron

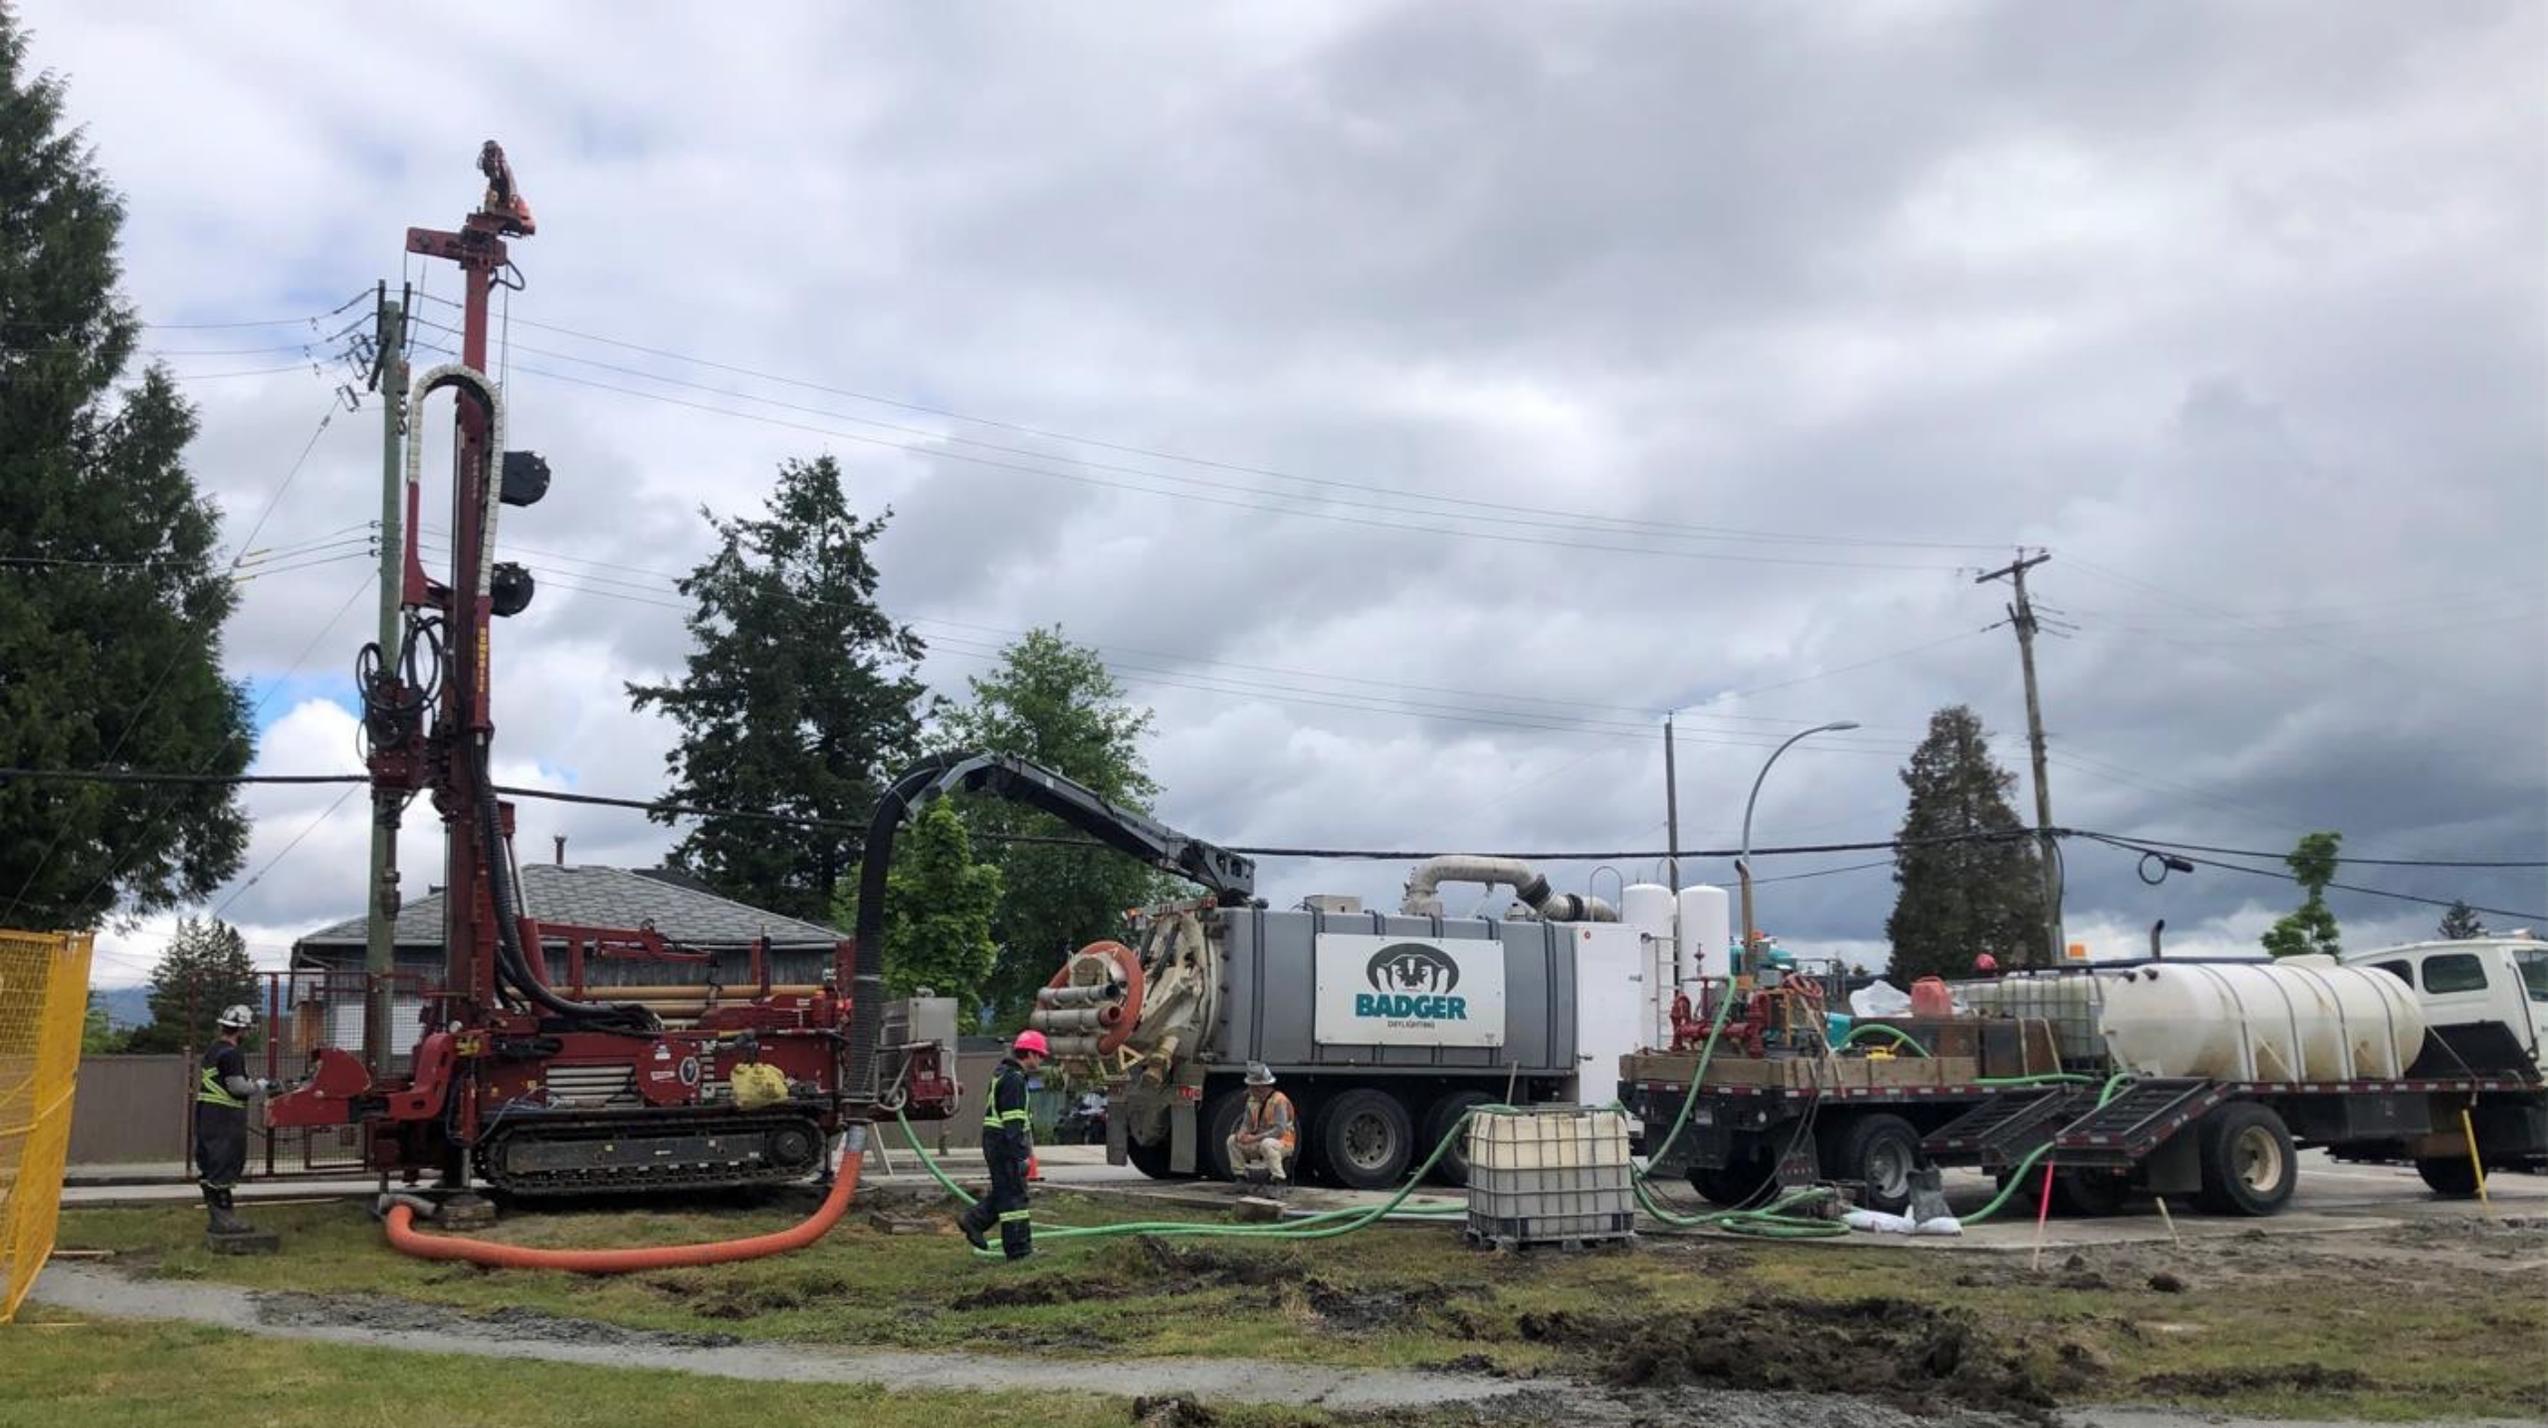
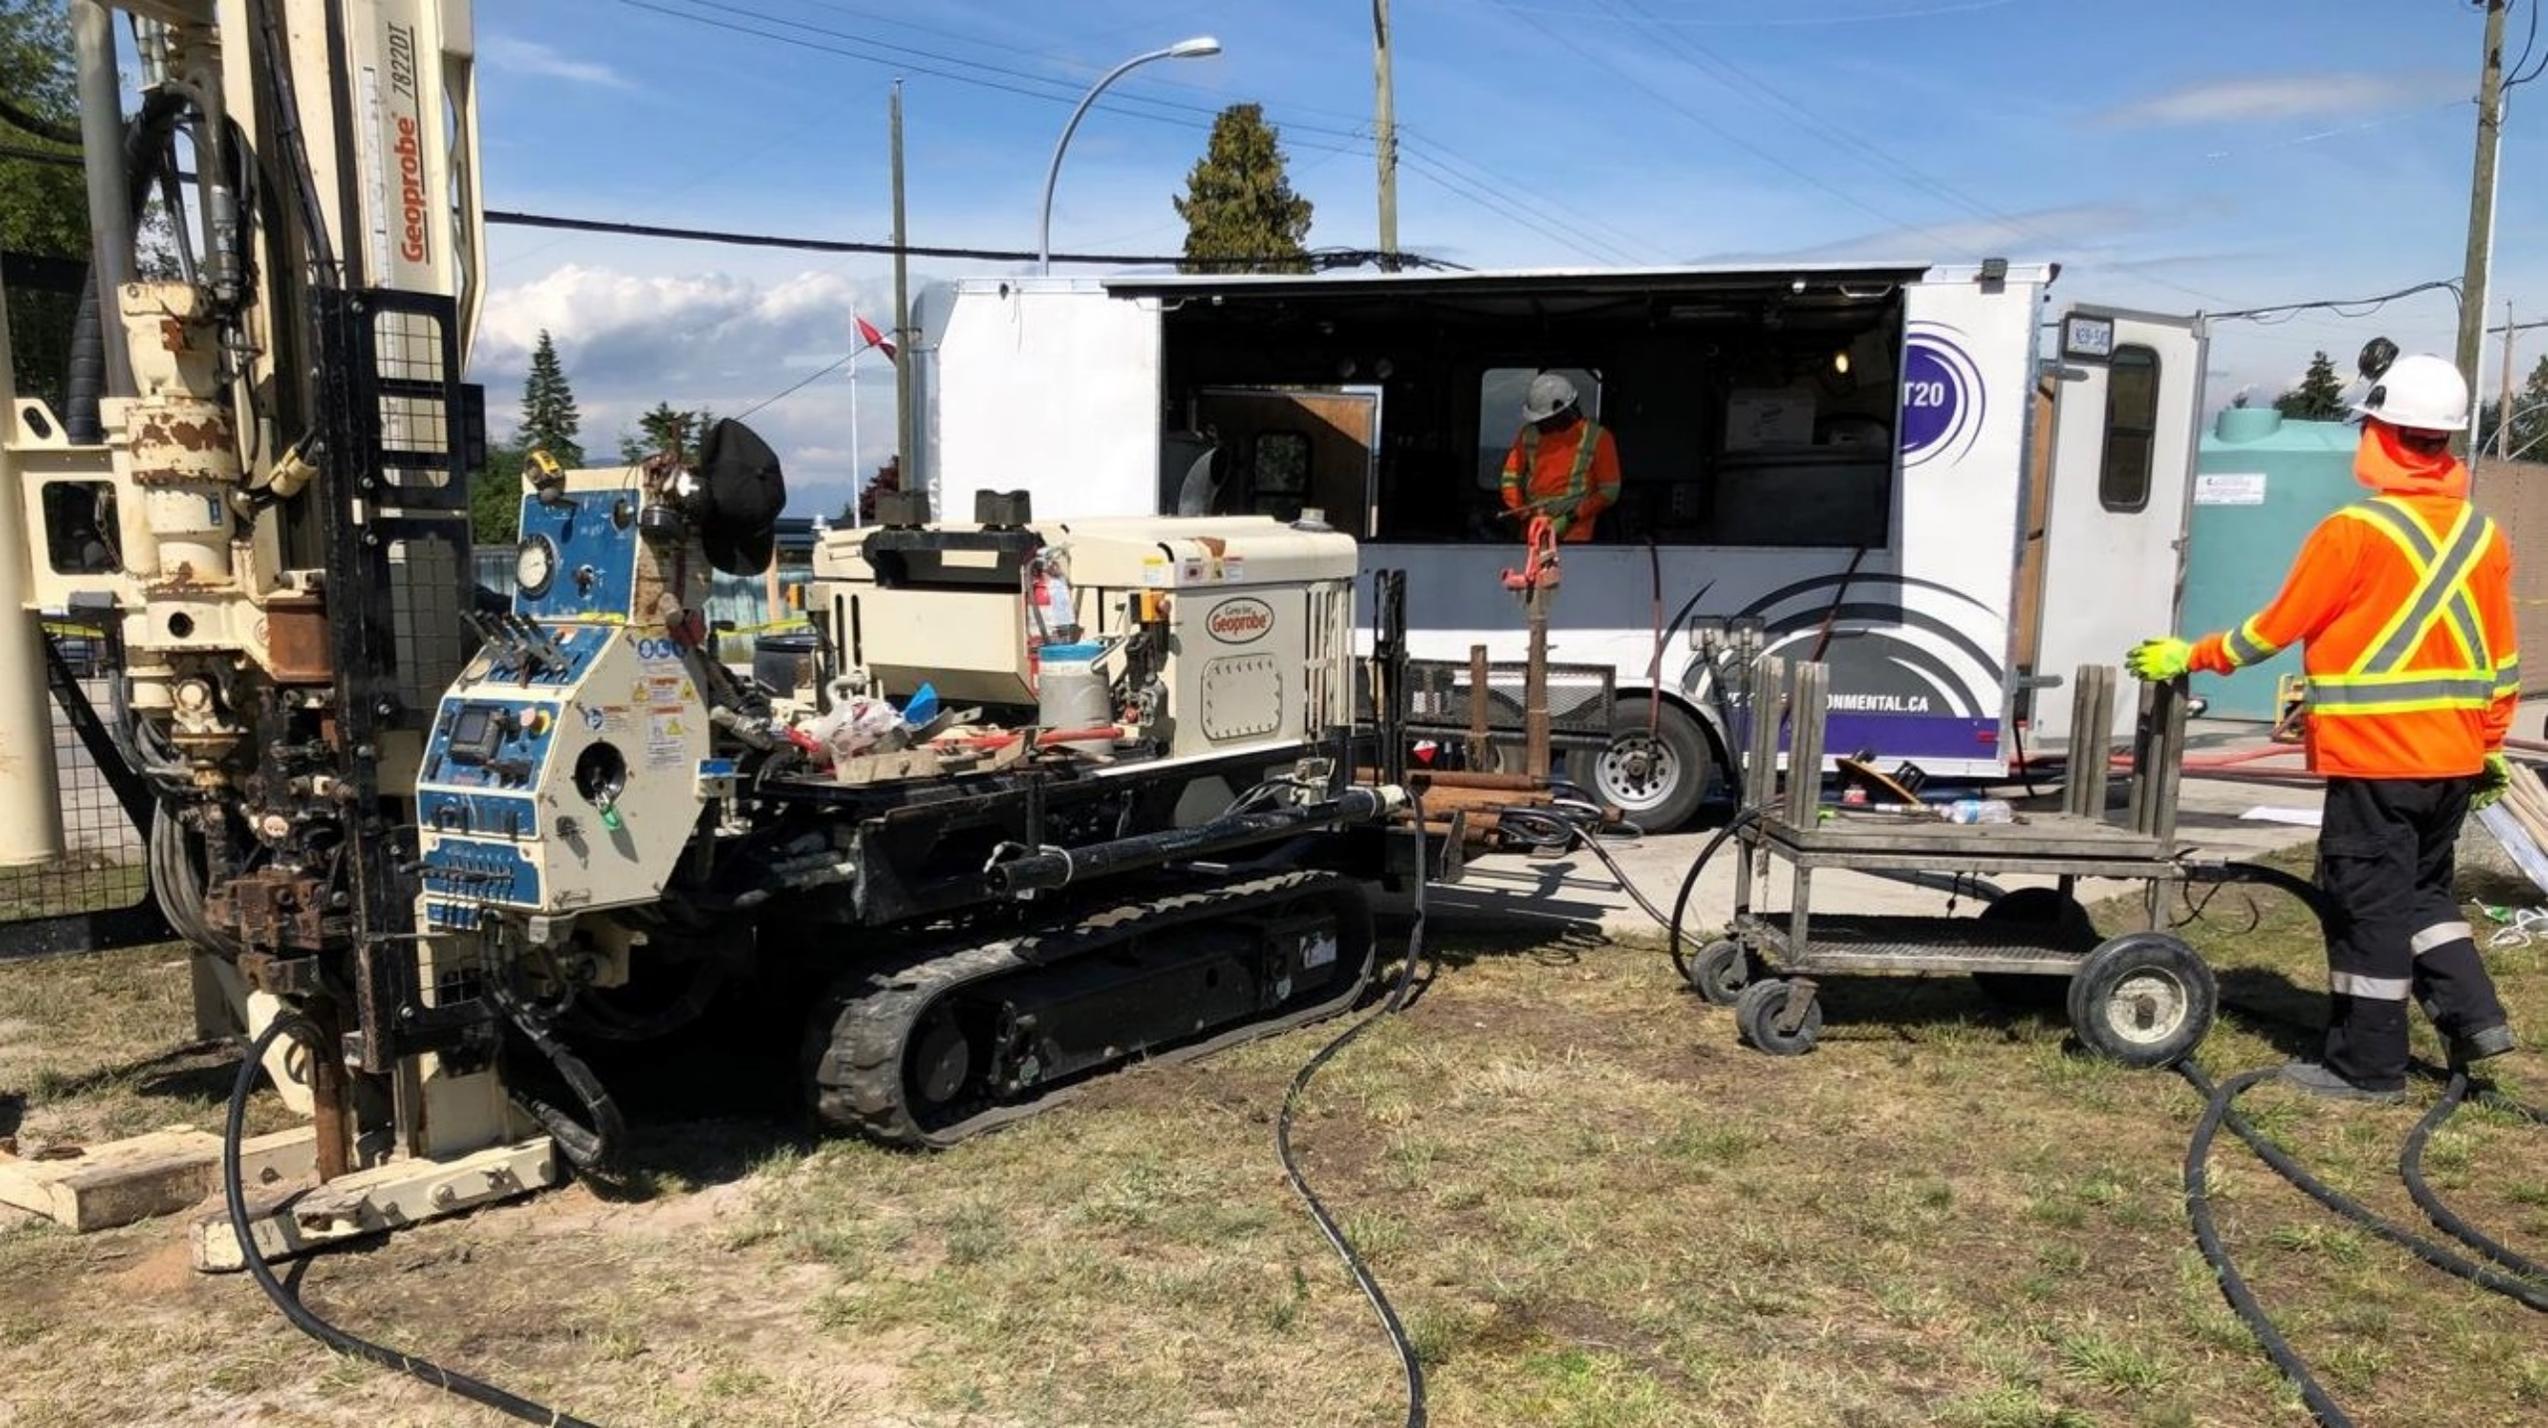
Geoprobe 7822DI

GeoTAPSM (Pre-Drill) Method
